2-D AND 3-D RESISTIVITY FOR LOCATING VOIDS BENEATH HIGHWAYS; THREE CASE STUDIES

*Richard W. Hammack
National Energy Technology Laboratory, Pittsburgh, PA*

ABSTRACT- The US Department of Energy National Energy Technology Laboratory (NETL) has successfully used DC resistivity to delineate potential subsidence zones beneath highways that are caused either by underground coal mines or nearby marble/limestone quarries. Three sites are discussed in this paper: 1) a segment of Interstate 70 in Ohio where ground subsidence into an underlying coal mine has resulted in an injury; 2) a roadway in eastern Maryland where the sudden opening of a sinkhole resulted in a fatality; and 3) a heavily traveled secondary roadway in central Pennsylvania that is prone to sinkhole development. The Ohio site (Interstate 70) has been intensely studied using seismic, ground penetrating radar, and exploratory drilling. At this site, a 2D resistivity profile acquired along the eastbound lane detected breaks in the overburden above the mine that exactly matched mine subsidence faults identified in seismic profiles. These fracture zones are areas where sinkhole development has occurred or is likely. The Marylan

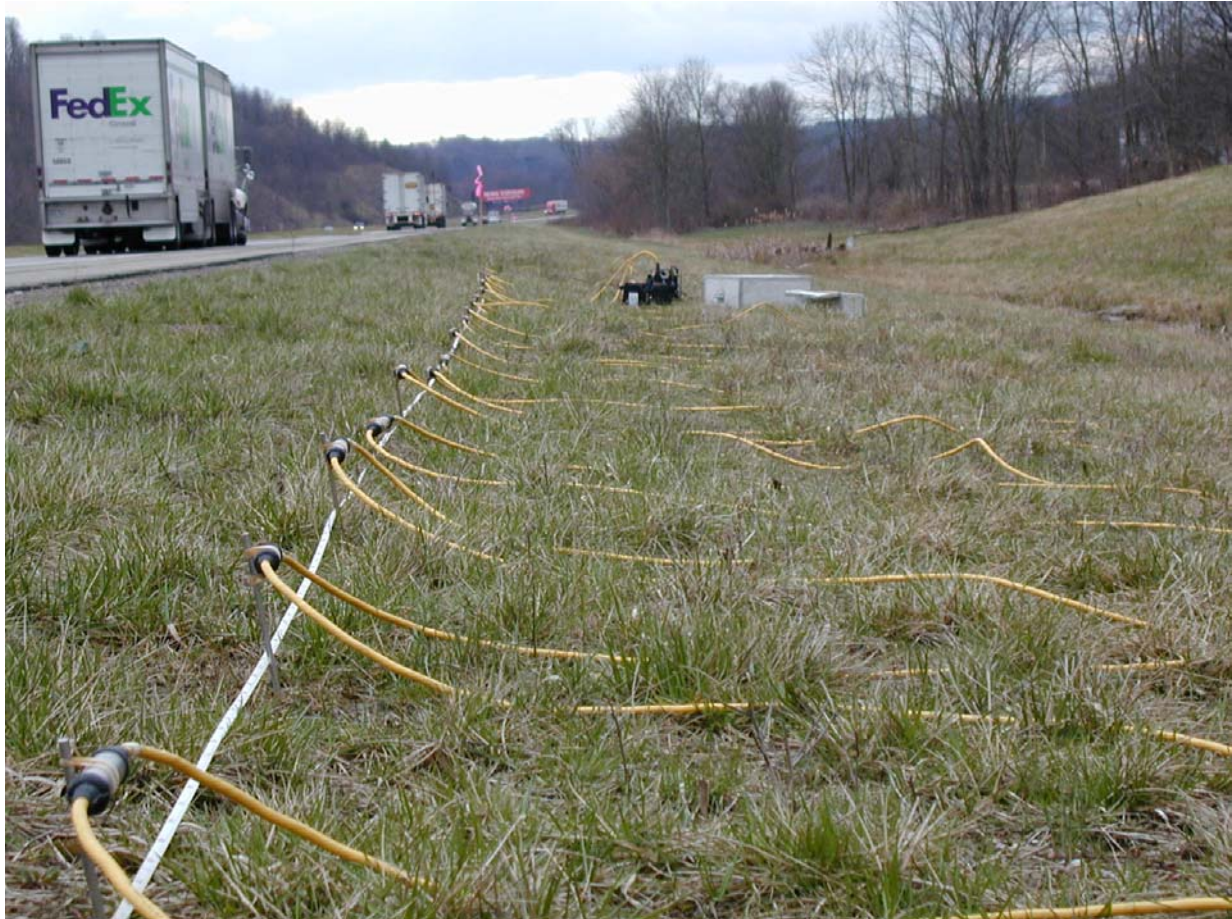
Figure 2 2D resistivity survey conducted along the shoulder of eastbound Interstate 70 near Cambridge, Ohio.

In 2002, seven years after the road closure and after the above geophysical techniques were tested at the site; NETL conducted a DC resistivity survey along the outside shoulders of the westbound and eastbound lanes (Fig. 2). The intent of this survey was to determine if DC resistivity could provide a better representation of subsurface conditions than the geophysical techniques already mentioned. At a minimum, DC resistivity was expected to provide information that when combined with results from other methods would provide a more comprehensive understanding of subsurface conditions.

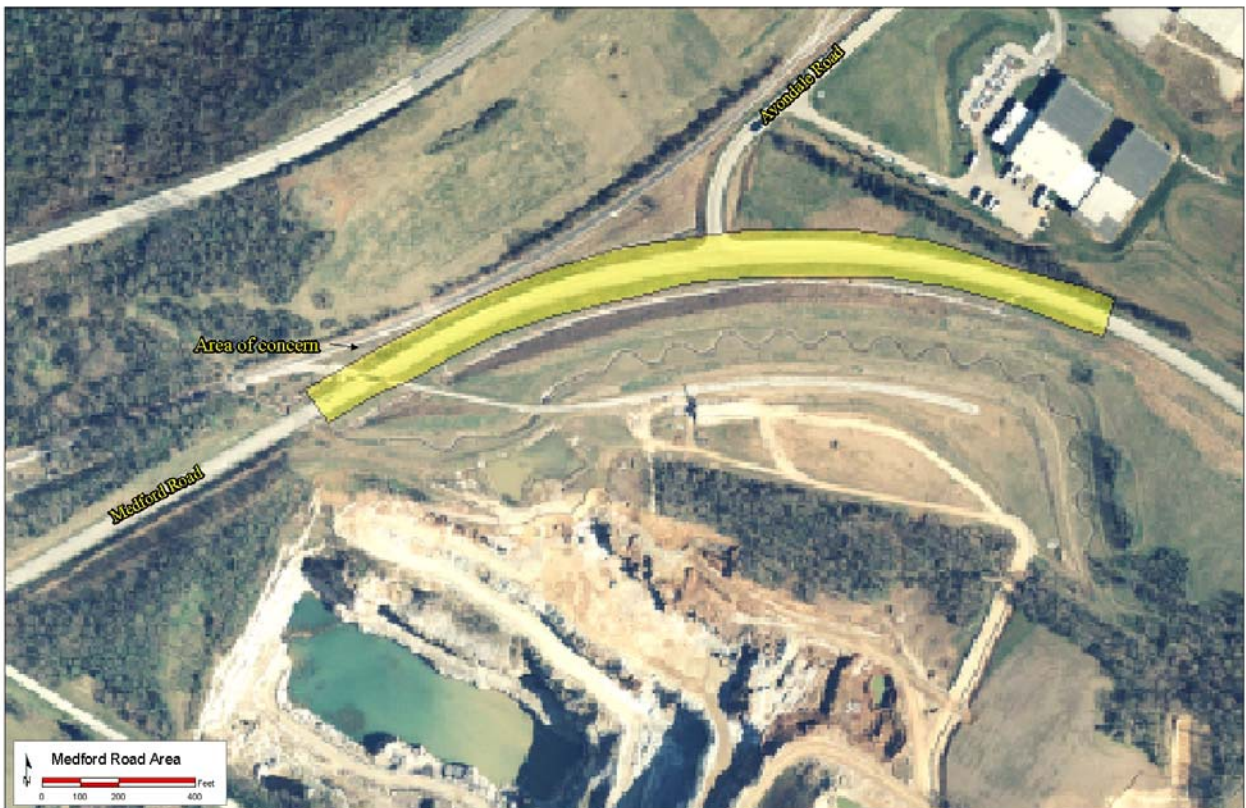
Figure 4 The location of a DC resistivity profile collected along a sinkhole-prone segment of Medford Road is depicted in yellow.

In 2003, NETL conducted a DC resistivity survey along a 500-m, sinkhole-prone segment of Medford Road, a two-lane blacktop road that is less than 200 m from the marble quarry (Fig. 4). Results of the resistivity survey (Fig. 5) provided a good depiction of the bedrock surface as well as the conductive clay and soil overburden. Most sinkhole occurrences were found to be on or near the edges of the bedrock platform that was interpreted from resistivity data. This finding was unexpected and 3D resistivity surveys are planned for sinkhole areas to better understand the relationship between sinkholes and the bedrock platform.

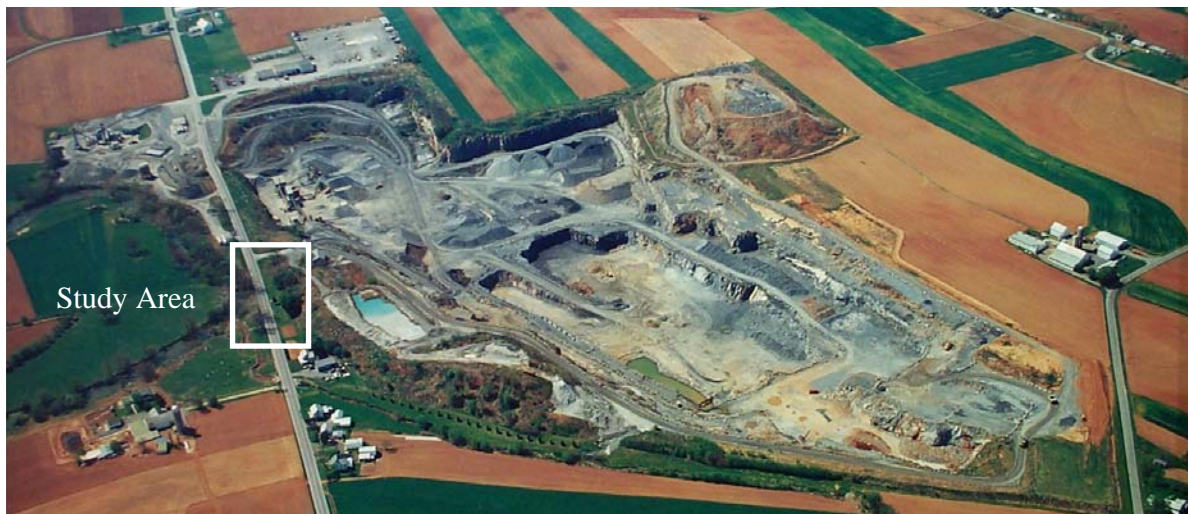
Figure 6 Map showing the location of a large, limestone quarry and adjacent river.

A large limestone quarry in east-central Pennsylvania is within 200 m of a small river (Fig. 6). Dye tracer tests indicate that water from the river is flowing into the quarry, presumably via solution cavities. Pumping water from the quarry back into the river costs quarry operators about \$5000 per month, an operating cost that they would like to avoid. Prior to this study, the quarry operators have unsuccessfully attempted to prevent river water from entering the subterranean passages by sealing the river bank adjacent to the quarry.

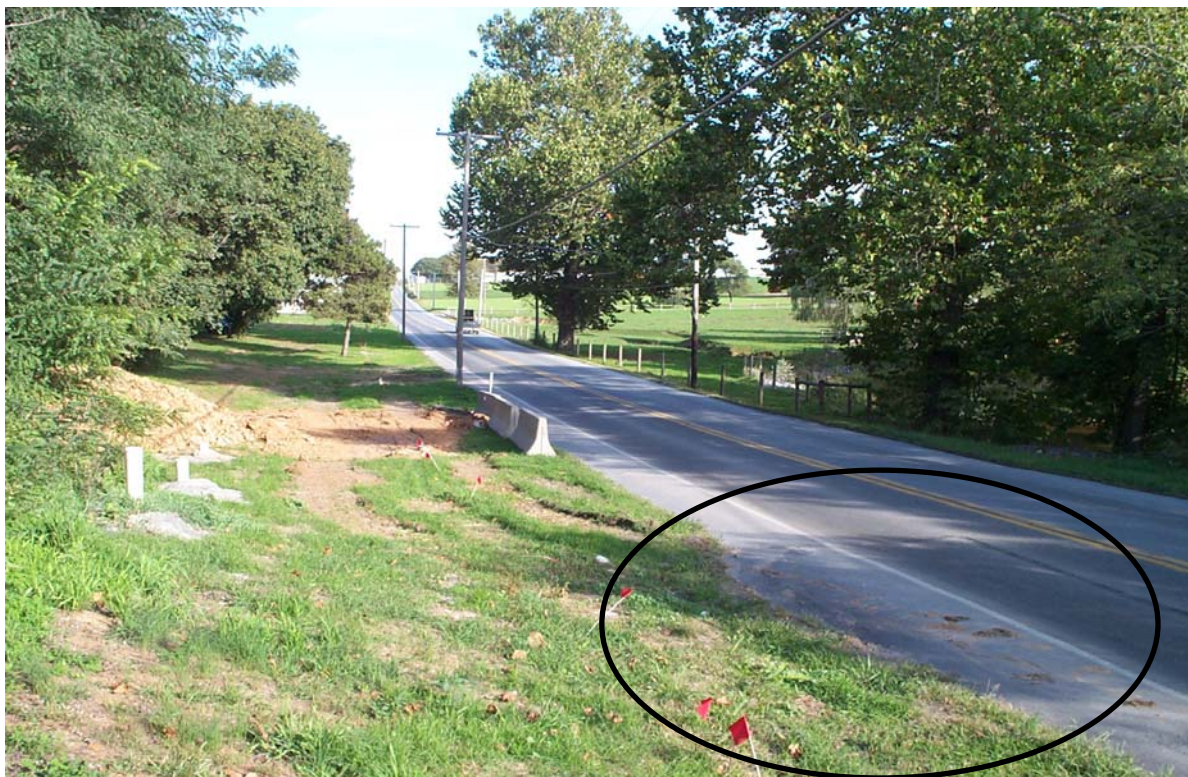
Figure 7 Red flags denote the location of resistivity survey. Active sinkhole area is shown by black circle.

In 2002, NETL acquired a resistivity profile along a segment of highway (Fig. 6) between the river and the quarry (Fig. 7). The intent of this survey was to locate voids that may serve as conduits for the flow of water into the quarry. Figure 8 is the model resistivity data, which indicates three resistive areas that were interpreted to be potential voids. Subsequent drilling by the quarry operator found that:

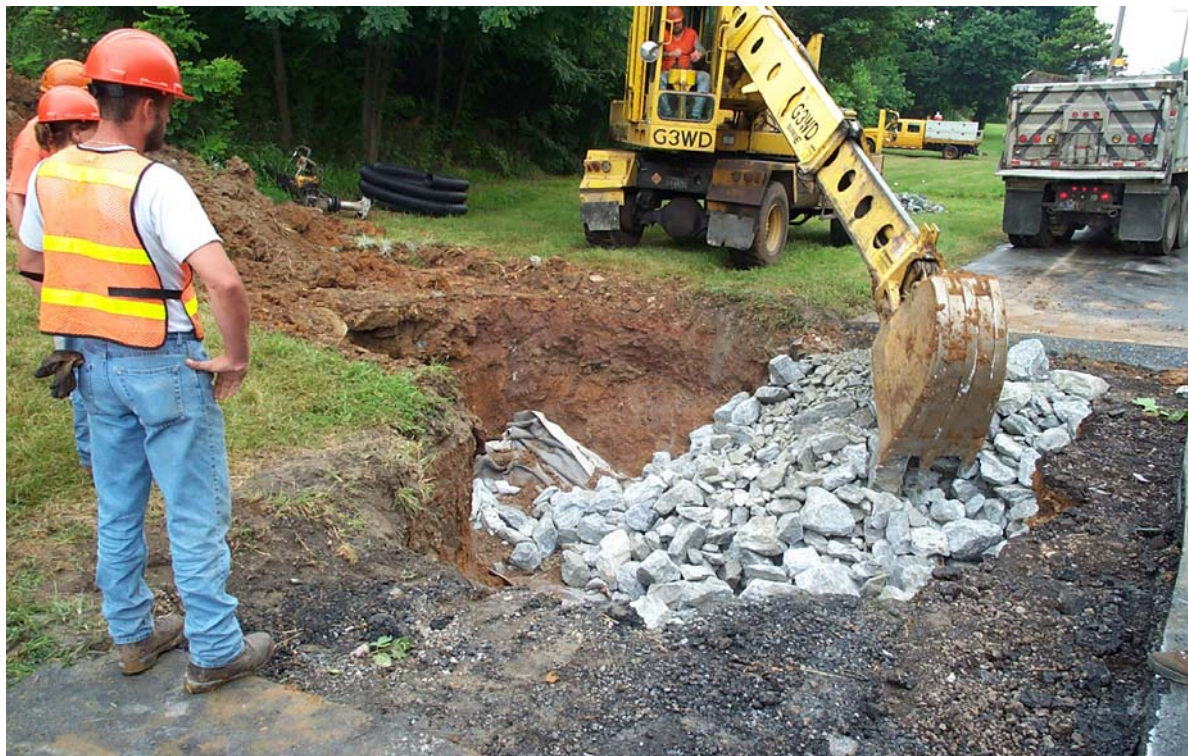
Figure 9 The resistivity survey crossed an active sinkhole that had been filled by PennDOT prior to the study.

The resistivity profile in Figure 8 crossed a sinkhole (Fig. 8, distance 20-24 m at 0-2 m depth) that had been repaired by PennDOT (Fig. 9). The sinkhole was filled with coarse rock that is depicted as a near-surface resistive area above a bedrock depression in Figure 8.
